Manhole Inspection Summary

Manhole # S07WW1018MH

Location Address: **5708 KEY AVE**

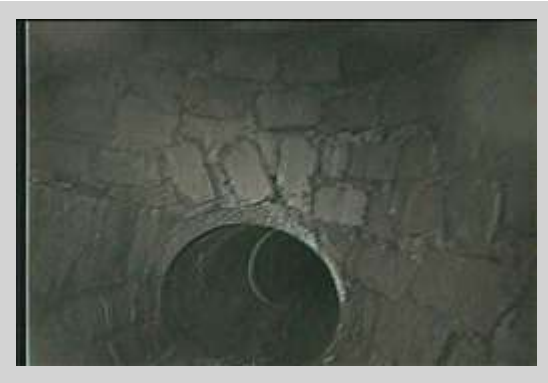
10 in. Circular Gravity Sewer Pipe Out @ 12 O'Clock

Pipe Material: **Clay** ☐ Pipe Lined

Invert Depth: **9.35** (ft.) Flow Characteristics: **Fast**

Deposits: ☒ None ☐ Mud ☐ Sludge ☐ Debris ☐ Grease

Infiltration: **None** Pipe Seal Cond: **Sound**

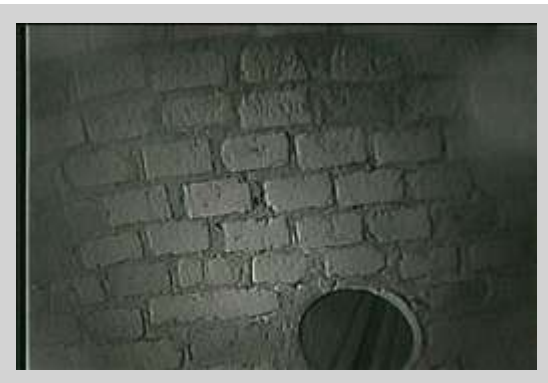
8 in. Circular Gravity Sewer Pipe In @ 3 O'Clock

Pipe Material: **Clay** ☐ Pipe Lined

Invert Depth: **8.97** (ft.) Flow Characteristics: **Fast**

Deposits: ☒ None ☐ Mud ☐ Sludge ☐ Debris ☐ Grease

Infiltration: **None** Pipe Seal Cond: **Sound**

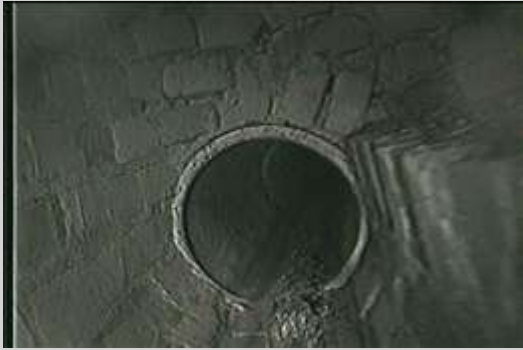
10 in. Circular Gravity Sewer

Condition: ☐ Sound ☐ Cracked ☐ Root Intrusion ☐ Loose Brick ☒ **Deteriorated**

Infiltration: ☐ None ☐ Joint ☐ Cracks ☒ **Mortar** ☐ Roots ☒ **Wall**

Barrel deterioration and infiltration.
